Bond degradation behavior of rebar and reinforced concrete confined with corroded stirrups in a marine environment: effects of concrete grade and casting position

MACR-2021-122-R1 | Paper: structures research

Keywords: BOND, CORROSION, CONCRETE STRUCTURES

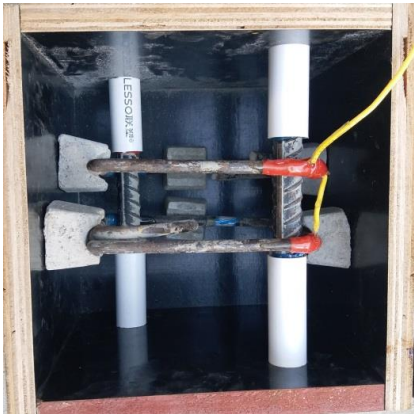
Fig. 1. Test specimen.

(a) Schematic drawing (all dimensions in mm).

(b) Specimen before concrete casting.

18 The stirrups were thoroughly dried in air and weighed using a scale before it was
19 shaped and tied to the main steel bars and positioned in wooded mold. Two ends of main
20 steel bars were first painted using by epoxy resin and then covered using electrical tape to
21 be prevented from any corrosion. As shown in Fig. 1(b), two main steel bars were
22 positioned horizontally, one close to the top surface of the mold and another to the bottom
23 surface of the mold prior cast of concrete. Such an arrangement of the main steel bar in
24 the concrete cube was to investigate the effect of concrete casting position.

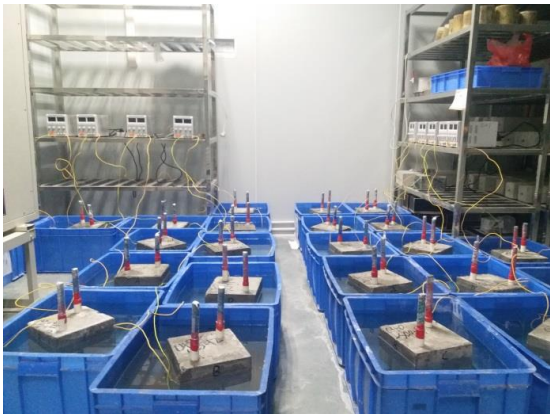
Fig. 2. Electrochemical corrosion of stirrup.

(a) Schematic drawing.

(b) photograph

To achieve an expected amount of corrosion within a reasonable period of time, an electrochemically accelerated corrosion technique was adopted in this test, as shown in Figs.2 (a) and (b). During the accelerated corrosion process, a constant current of 150 $\mu\text{A}/\text{cm}^2$ was applied to the stirrups in the concrete specimens via copper wire from a power supply. The expected mass loss of the tested specimens ranged from 0% to 20%. The mass loss was used to measure the amount of corrosion of the stirrups. The corrosion times of stirrups was estimated using Faraday's law

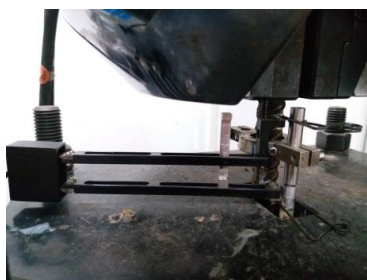
Fig. 3. Loading and measuring system.

(a) Schematic drawing

(b) Loading setup

(c) Loading-end extensometer.

(d) Free-end extensometer.

4 Figs 9, 10 and 11 show the typical bond stress and slip curves of the tested specimens
5 that had the strengths of concrete C20, C40 and C50 and the amounts of corrosion from 0%
6 up to 20%. Here, the slip is the displacement measured at the load end of main steel bar.
7 The bond stress was calculated by dividing the applied pull out force using bar surface
8 area, as

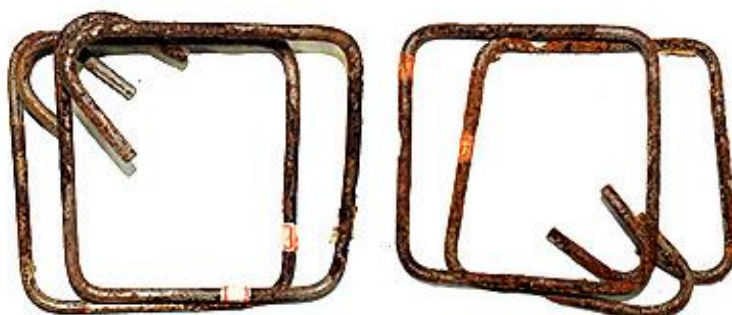
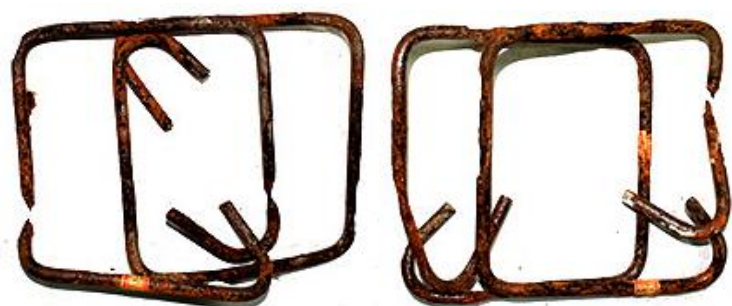
Fig. 4. Corroded stirrups after cleaning.

(a) C50-SC5-5($\xi_s = 5.78\%$) (b) C50-SC10-7($\xi_s = 11.34\%$)

(c) C50-SC15-4($\xi_s = 16.07\%$) (d) C50-SC20-4($\xi_s = 20.89\%$)

3 After the loading test, the specimens were broken down and the corroded stirrups
4 were taken away from the concrete specimens, as typically shown in Fig. 4. It is clear that
5 with an increase of the amount of corrosion, the morphologies of stirrups changed
6 significantly. For about 5% of corrosion the surfaces of corroded stirrups did not change
7 too much with some less significant pitting scattered on stirrup surface. However, if
8 amount of the stirrup corrosion increased to about 11%, more serious pitting developed on
9 stirrup surface when the amount of stirrup corrosion reached about 15% local reduction of
10 cross section of the stirrups become obvious and the stirrup surface become significantly
11 inhomogeneous. When the amount of corrosion increased to about 20% residual surfaces
12 of stirrups varied greatly along its length. Stirrup surface become substantially
13 inhomogeneous.
